## INFORMATION REPORT

USSR (Black Sea)	REPORT	-00	•	25X1
SUBJECT	Port of Novorossiysk	_	- 20 . 38	Augus	t 1953
		NO. OF PAGES			
DATE OF	INFO.	REQUIREMENT NO. RE	)		25 <b>X</b> 1
PLACE A	CQUIRED	REFERENCES			20/1

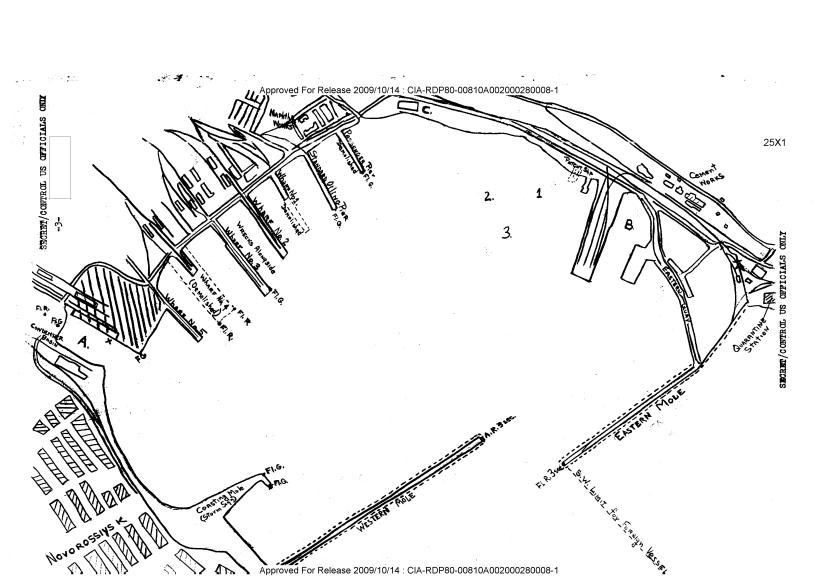
SECRET/CONTROL US OFFICIALS ONLY	23/
	<b>-2-</b>	
7•	The area extending in a southwesterly direction from Wharf No. 5 to a point marked F.G., and then in an east-northeasterly direction to a point marked X on the sketch, was reported to be filled in, and to have a stone or cement faced quay, with approximately 250 meters of frontage forming the southwest boundary.	·

8.	Within the area marked A on the sketch, there are moorings for naval craft.  15 small naval craft of either the MO IV class or  MBK 651 class (sic).	25X1
9•	At point B, a floating dock of approximately 5,000 tons, and also a cargo vessel of about 8,000 tons dead weight. This vessel appeared to be new.	25X
